National Transportation Safety Board

Review of Recent Icing Accidents, Incidents, and NTSB Recommendations Regarding In-flight Icing

Daniel R. Bower, Ph.D.
Office of Research and Engineering

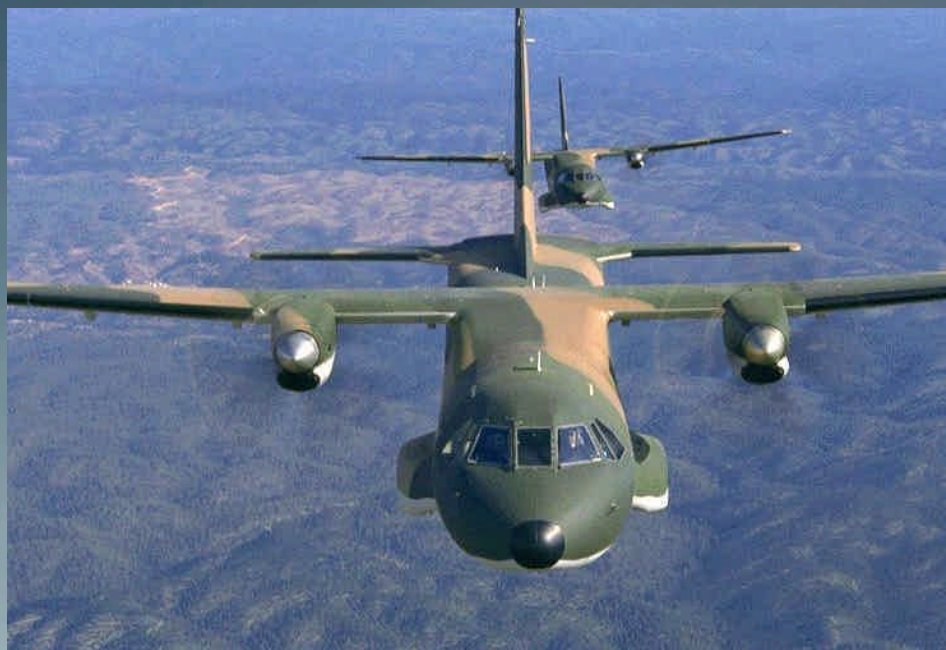
May 2001, Malatya, Turkey, CASA CN-235 Turboprop, Military Aircraft

- 34 fatalities
- Safety Board assisted Turkish Military with FDR/CVR
- FDR data was consistent with an icing encounter

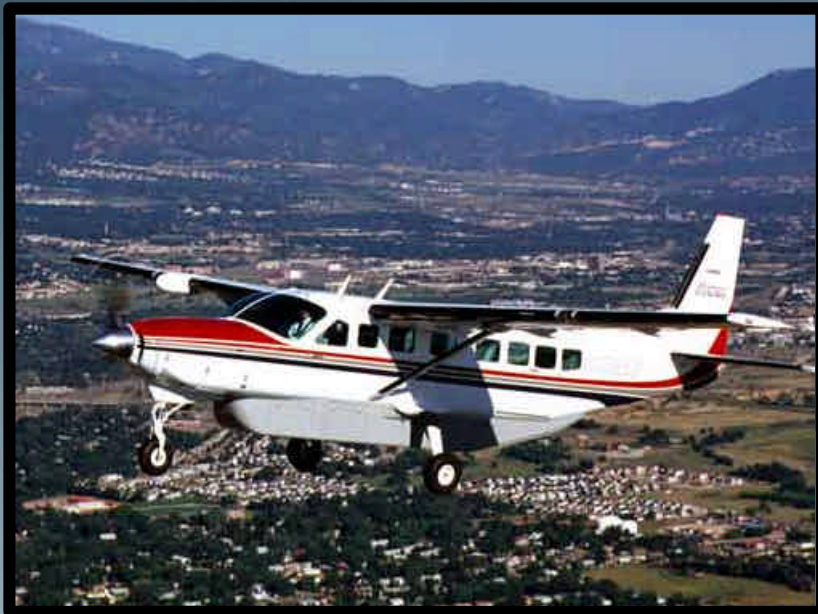
Cessna 208B Caravan:

- Single-engine turboprop airplane
- Seat 10 pax, or haul freight
- 6 icing-related accidents (5 fatal) in last 2 years

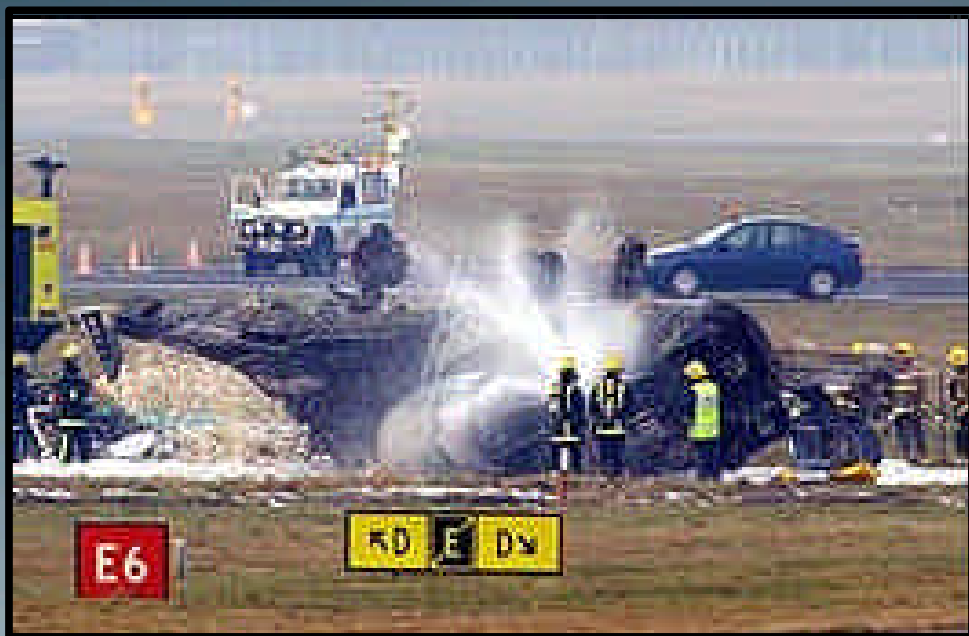
Suspected Airframe Icing: Bombardier Challenger CL-600 Birmingham, England – Jan. 4, 2002

- 5 fatalities
- Crashed During Takeoff
- Was not de-iced prior to takeoff
- UK AAIB investigating with NTSB participation

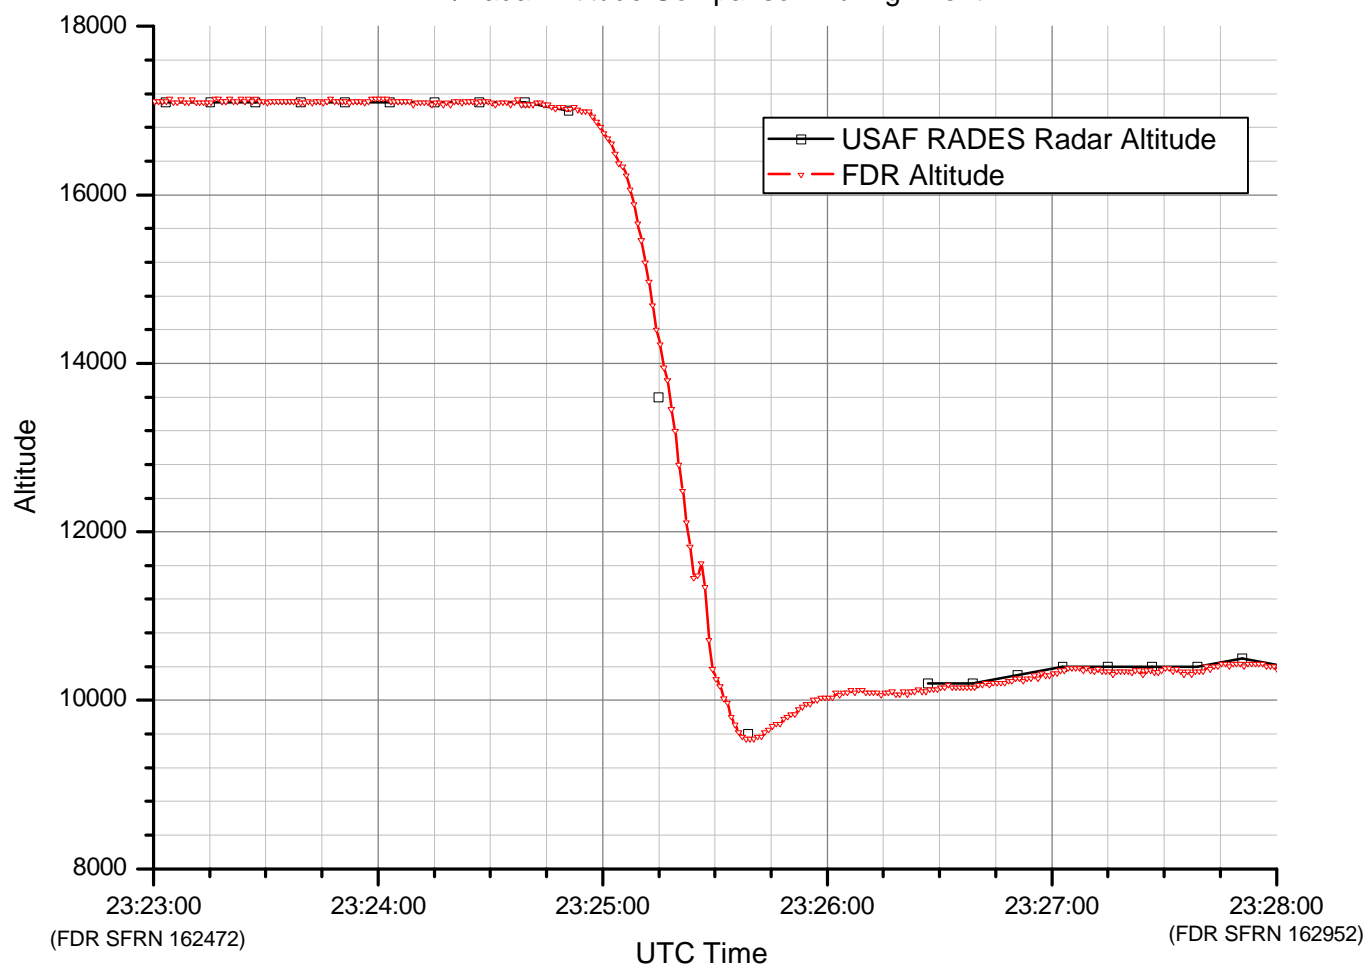
Comair 5054 - March 19, 2001
FDR/Radar Altitude Comparison During Event

- 8000 ft altitude loss, structural damage to horizontal tail and elevator
- Pilots reported using de-icing boots (3 minute activation cycle) and seeing some remnants of ice on boots after boot activation
- Indications from FDR, CVR Ice Detector was active
- Possible SLD conditions (SAT – 4 Deg C)

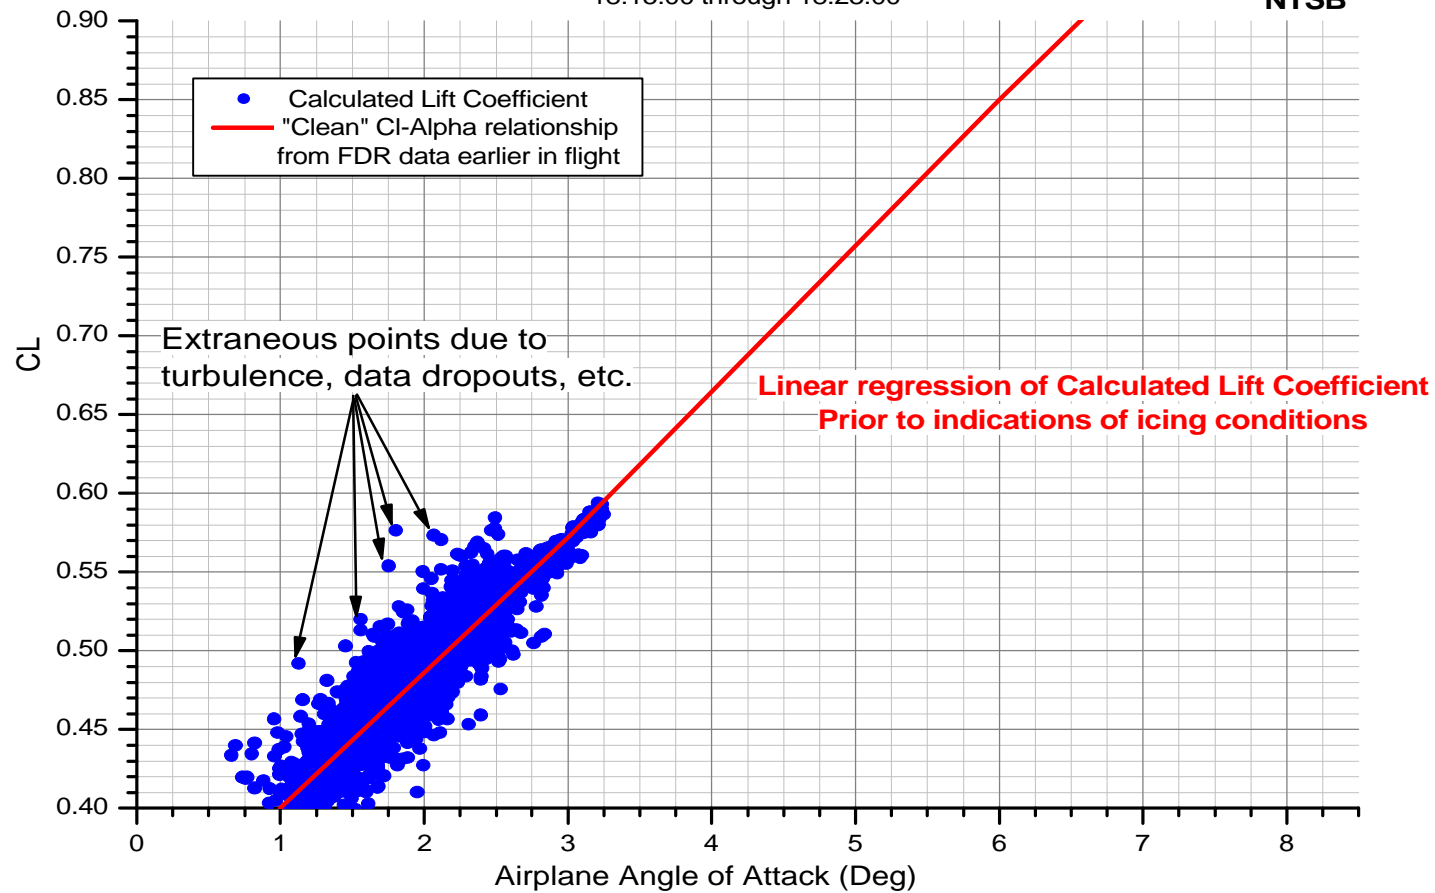
Comair 5054
Lift Coefficients Determined from FDR Load Factors
18:15:00 through 18:23:00

- During steady portion of FDR data prior to evidence of ice accretion, plotted derived lift coefficient versus recorded angle of attack to derive “clean” airplane lift curve slope (CL_{α})
- Compare “clean” lift curve to the lift coefficient calculated during icing encounter, prior to upset

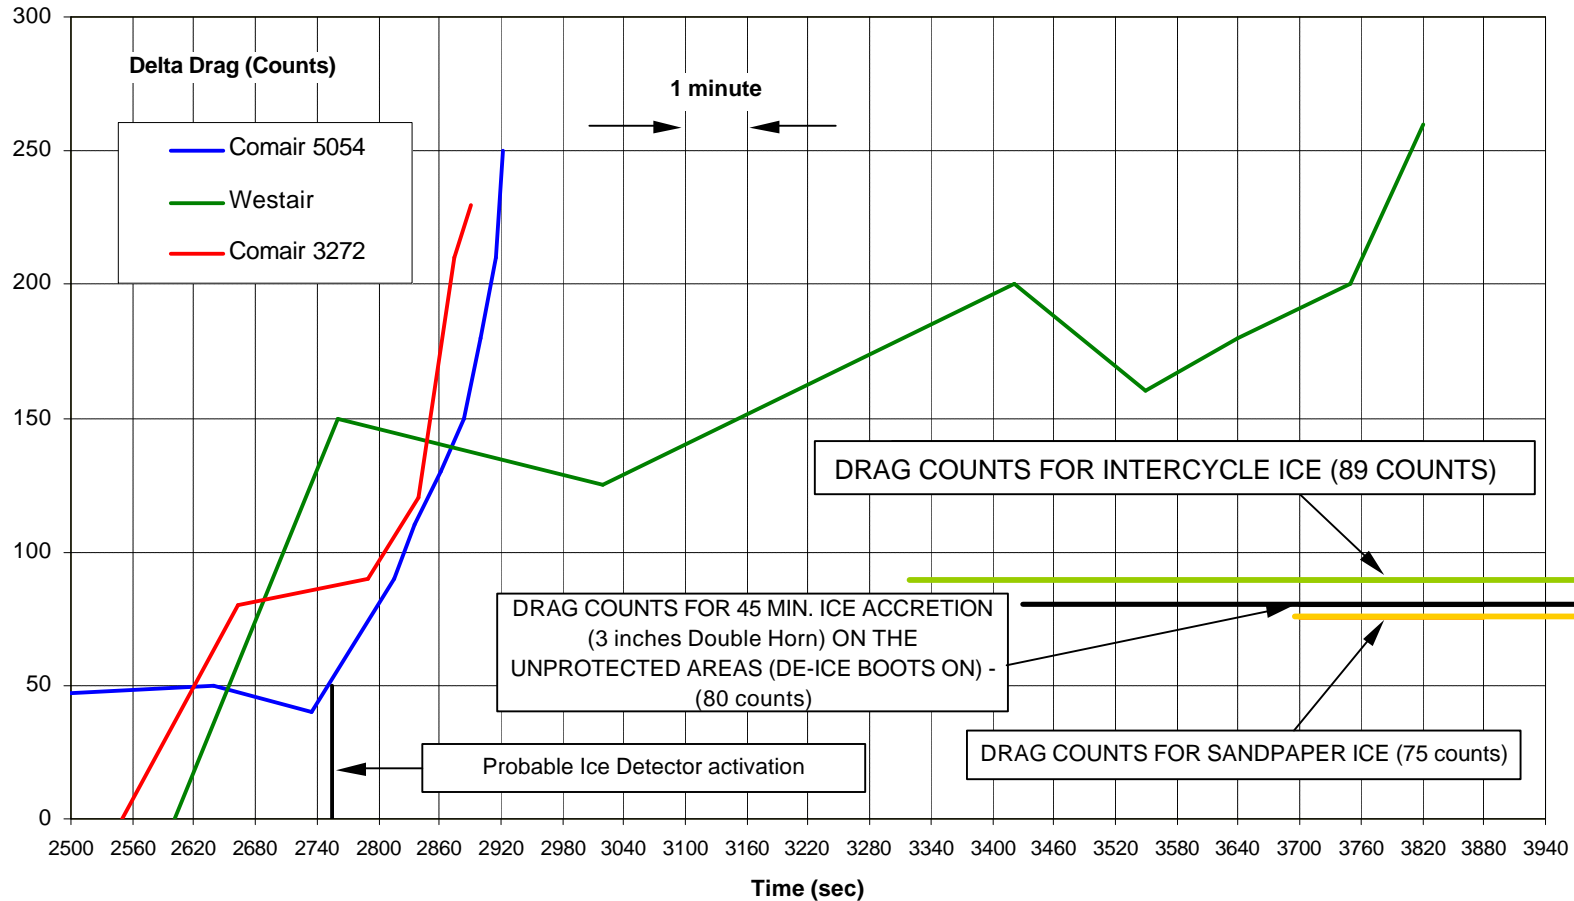
EMB-120 DRAG DUE TO ICE ANALYSIS
Comparison between Comair 5054, Comair 3272 and Westair

- There still can be a perception amongst some flightcrews that de-ice boots are a “fire and forget” system
- Airplanes are operating in SLD environments for which they are not certified
- Intercycle ice shapes can cause large aerodynamic penalties, larger than some ice shapes currently used in certification
